# Manhole Inspection Summary

Manhole # S61CC\_007MH

Insp Date: **2/25/10 3:56 PM**

**Location** Address: **Pulaski**

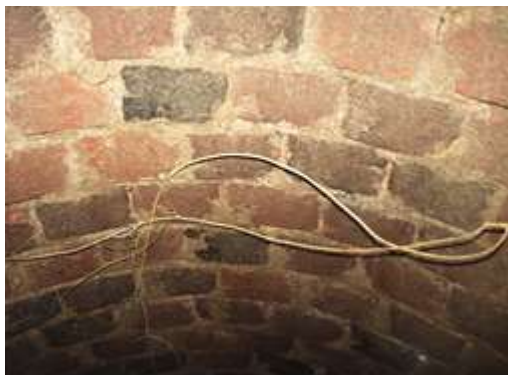
Defect 3

roots

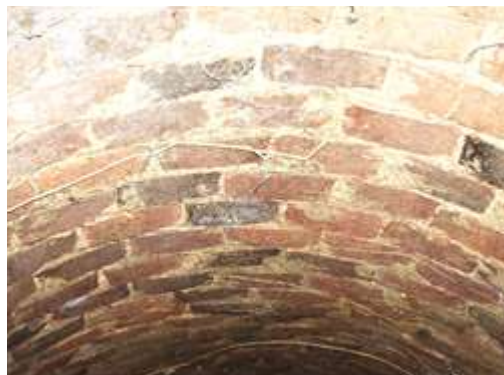
Defect 2

roots

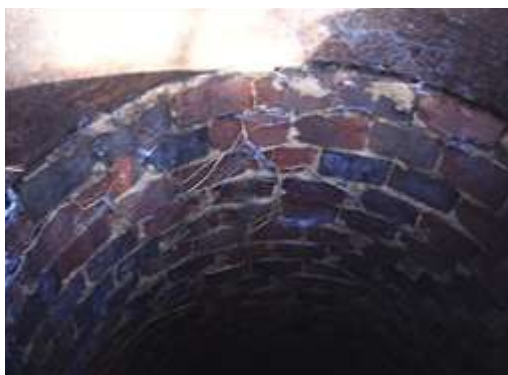
Defect 1

roots

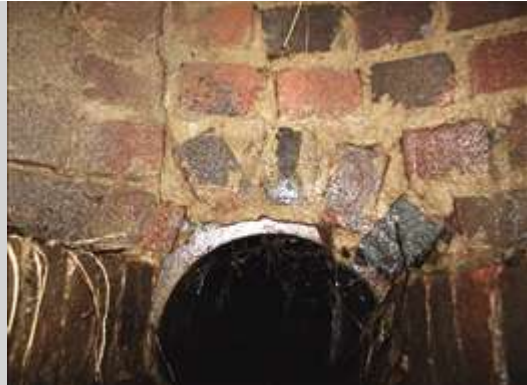
12 O'Clock Outflow

10 in. Circular Gravity Sewer  
Pipe Out @ 12 O'Clock

Pipe Height: **14.4** (in.) Rod and Bar (Angled)  
Pipe Material: **Clay** ☐ Pipe Lined  
Invert Depth: **11.00** (ft.) Flow Characteristics: **Slow**  
Deposits: ☒ None ☐ Mud ☐ Sludge ☐ Debris ☐ Grease  
Silt Depth: (in.) Deposits Extent:  
Infiltration: **None** Pipe Seal Cond: **Sound**

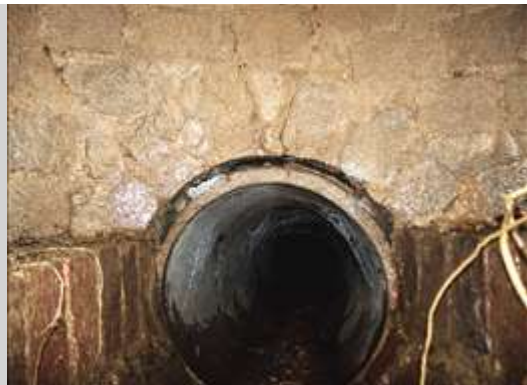
6 O'Clock Inflow

10 in. Circular Gravity Sewer  
Pipe In @ 6 O'Clock

Pipe Height: **14.4** (in.) Rod and Bar (Angled)  
Pipe Material: **Clay** ☐ Pipe Lined  
Invert Depth: **10.92** (ft.) Flow Characteristics: **Slow**  
Deposits: ☒ None ☐ Mud ☐ Sludge ☐ Debris ☐ Grease  
Silt Depth: (in.) Deposits Extent:  
Infiltration: **None** Pipe Seal Cond: **Sound**
